**Birchwood**  
Archaeological Services

## The Shafer Farm Dutch Barn Complex History *Warnerville, New York*

2009 David Moyer, Anna Blinn Cole and Rebecca Moyer  
*Phase IA/IB Cultural Resources Survey, Maranatha Family Center, Town of Richmondville, Schoharie County, NY.* Prepared by Birchwood Archaeological Services for Stella McKenna. On File, New York State Office of Parks, Recreation and Historic Preservation, Waterford New York.

## Shafer Farm Dutch Barn Complex

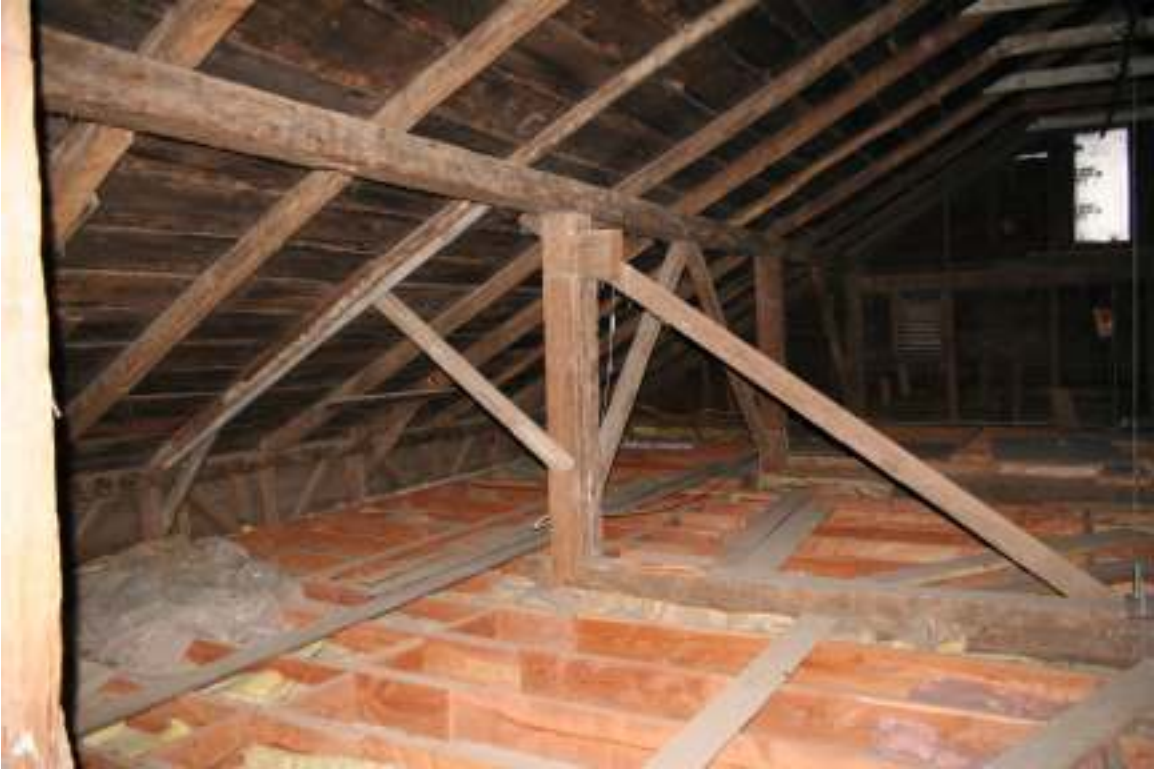
scribe rule method as carpenter's marriage marks are visible on accessible joints (Photo 12). Most of the visible framing members appear to be original. The siding and roof boards, however, have been replaced. Some framing has been added in the 20<sup>th</sup> century to add additional support such as collar ties and lateral sway bracing (Photo 11).

Photo 11. View of the interior of Dutch barn showing rafters, H-bent column, anchor beam, cut-off transverse tie-beam, longitudinal sway bracing and modern bracing, facing southeast.

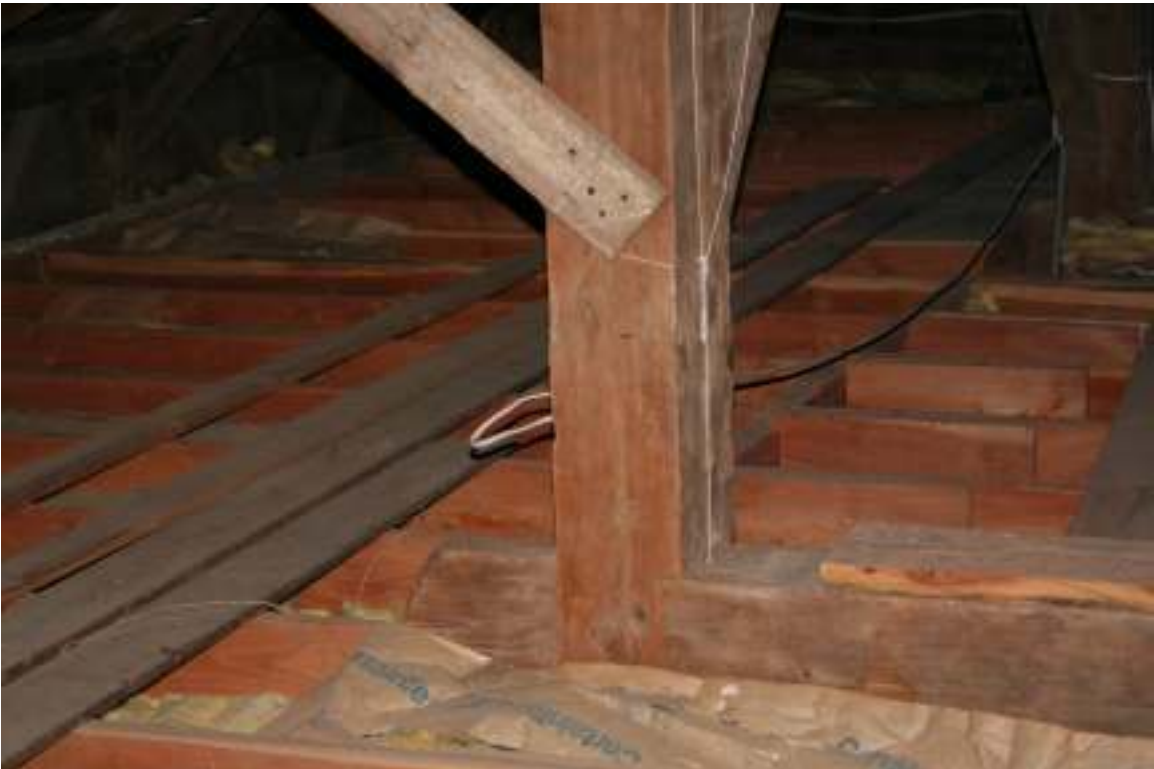
Photo 12. Detail of anchor beam and H-bent column intersection showing marriage marks, facing south.

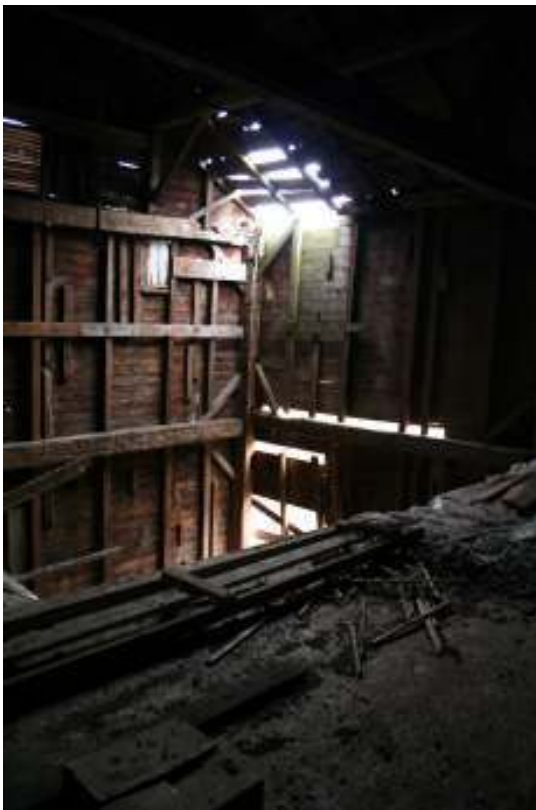
Together these four barns reflect an agricultural complex that served to meet the needs of a large dairy farm. As a stand alone structure, the appended Dutch barn represents an architectural expression of adaptation and innovation isolated to a small region. “T-bone” additions such as this are an anomaly to Dutch barn construction isolated to the Schoharie Valley region. While the Dutch barn is itself a rare survival in Schoharie County, its role through time in the expansion and evolution of the Shafer Farm lends itself to a wider realm of significance. The two smaller barn buildings are in good condition. The Dutch barn has some structural issues on its northern gabled end where the sill and end girt have been removed (Photo 23). The English barn addition suffers from isolated water damage due to a missing section of roof in its northwestern corner (Photo 16). The buildings are otherwise in fair condition (Photo 7, 8 and 52).

Photo 16. View of the interior northwest corner of the English threshing barn showing hay mow area below and roof damage above, facing northwest.

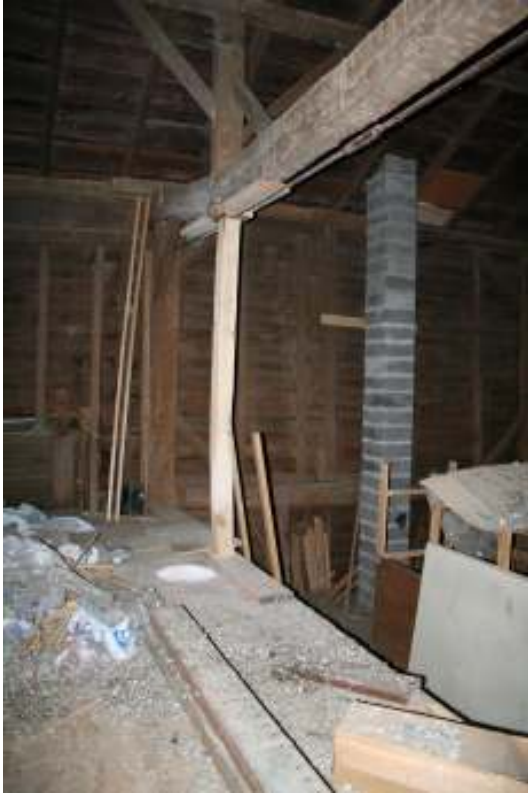
The rear, north facing façade of the Dutch barn opens into an English threshing barn addition, creating an overall T-shaped building (Page F35; Photos 6 and 7). A perpendicular English barn addition to the rear of a Dutch barn is a pattern uniquely found in the Schoharie Valley (Larson 1998; Zoch 2000). The English barn is rectangular in footprint and measures 53 x 20 ft, nearly doubling the footprint of the Dutch barn. An addition of this size would have intentionally been added to increase the volume capacity of the original barn. The English barn has a traditional interior arrangement with a central nave accessed by two wagon doors on the side-gabled, northern façade. A queen-post truss system supports the roof and rafters meet in an open joint. Two bays on either side of the central nave would have provided space for animal stalls or a haymow (Photo 16). Major timbers within the English barn are large, hand-hewn pieces. Studs, braces and rafters are vertical-sash sawn. Major joints are mortise-and-tenon and fastened with wooden pegs. The English barn addition appears to have been constructed using the square-rule method, not displaying any obvious marriage marks. Square-rule construction became wide-spread around 1820. In the 20<sup>th</sup> century, a concrete block chimney was added in the northeast part of the barn for an unknown purpose (Photo 17).

Photo 17. View of the interior north wall of the English threshing barn showing a modern concrete block chimney stack, facing southwest.

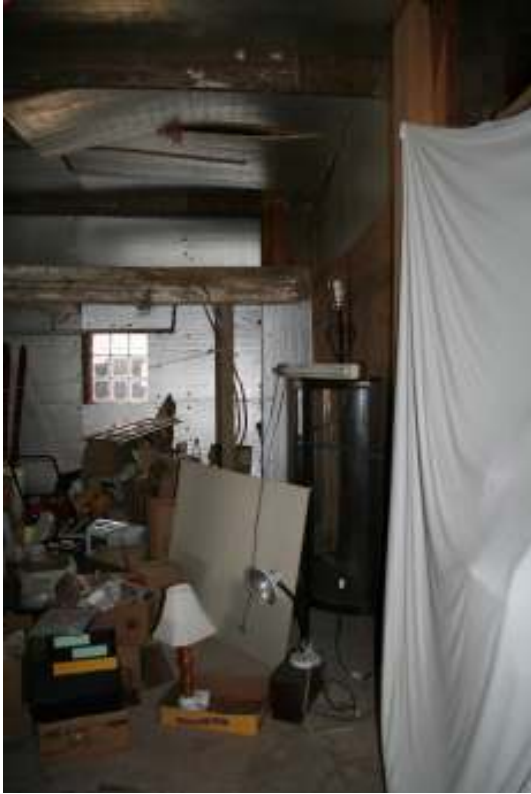
Photo 23. View of Dutch barn ground-level looking at northwest corner where both the sill and end girt are missing, facing west.
