**Birchwood**  
Archaeological Services

## The Shafer Farm Dutch Barn Complex History *Warnerville, New York*

2009 David Moyer, Anna Blinn Cole and Rebecca Moyer  
*Phase IA/IB Cultural Resources Survey, Maranatha Family Center, Town of Richmondville, Schoharie County, NY.* Prepared by Birchwood Archaeological Services for Stella McKenna. On File, New York State Office of Parks, Recreation and Historic Preservation, Waterford New York.

## Shafer Farm Dutch Barn Complex

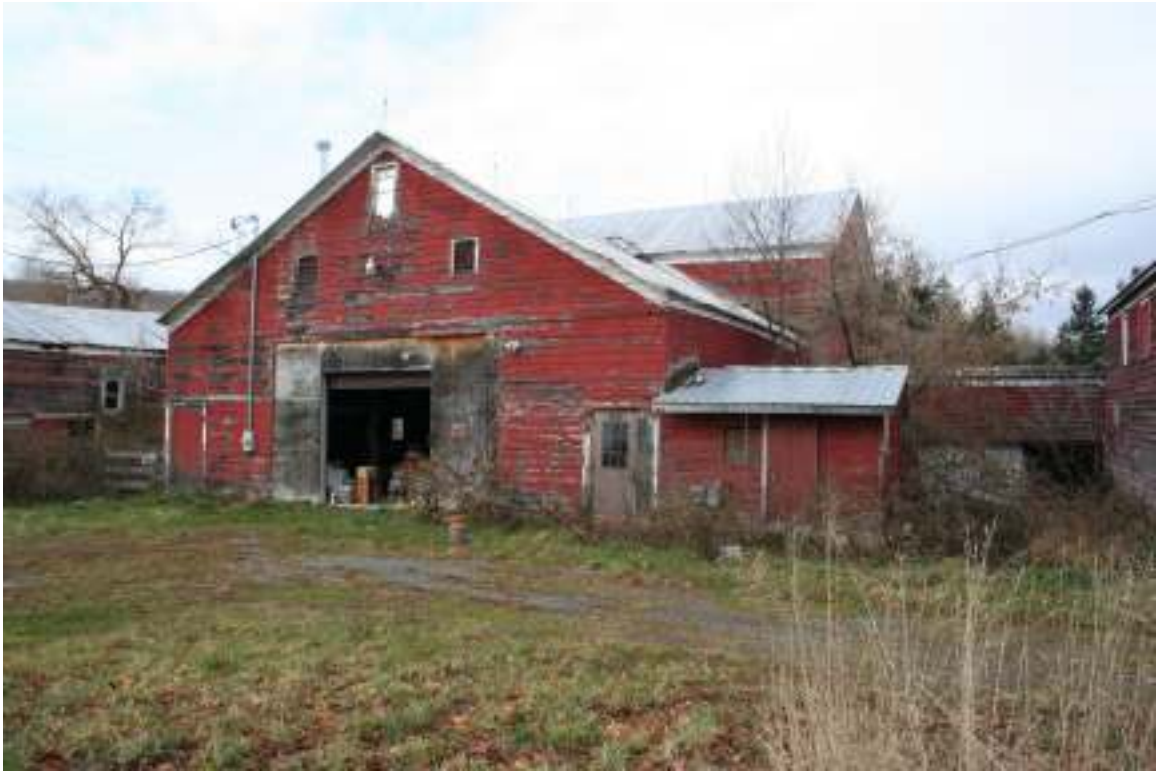
Photo 1. View of Shafer Farm Dutch Barn from the north side of NYS Route 7, facing northwest.

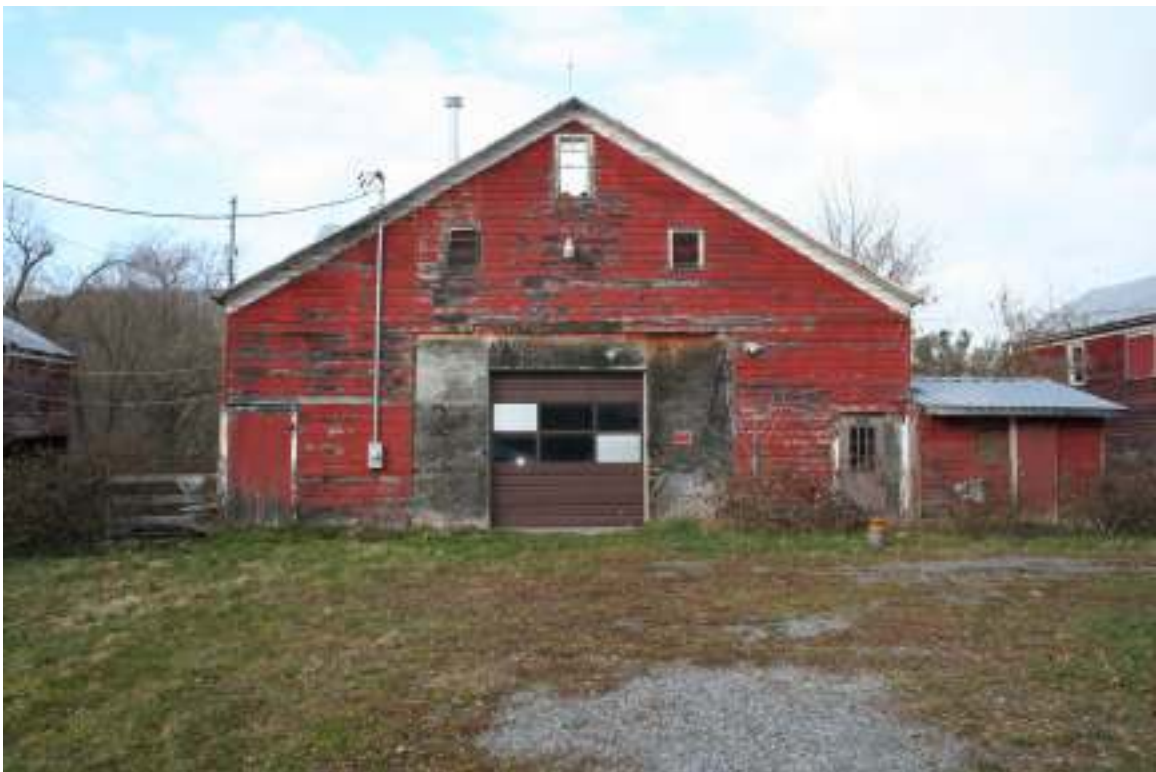
Photo 2. View of Dutch barn from the north side of NYS Route 7, facing north

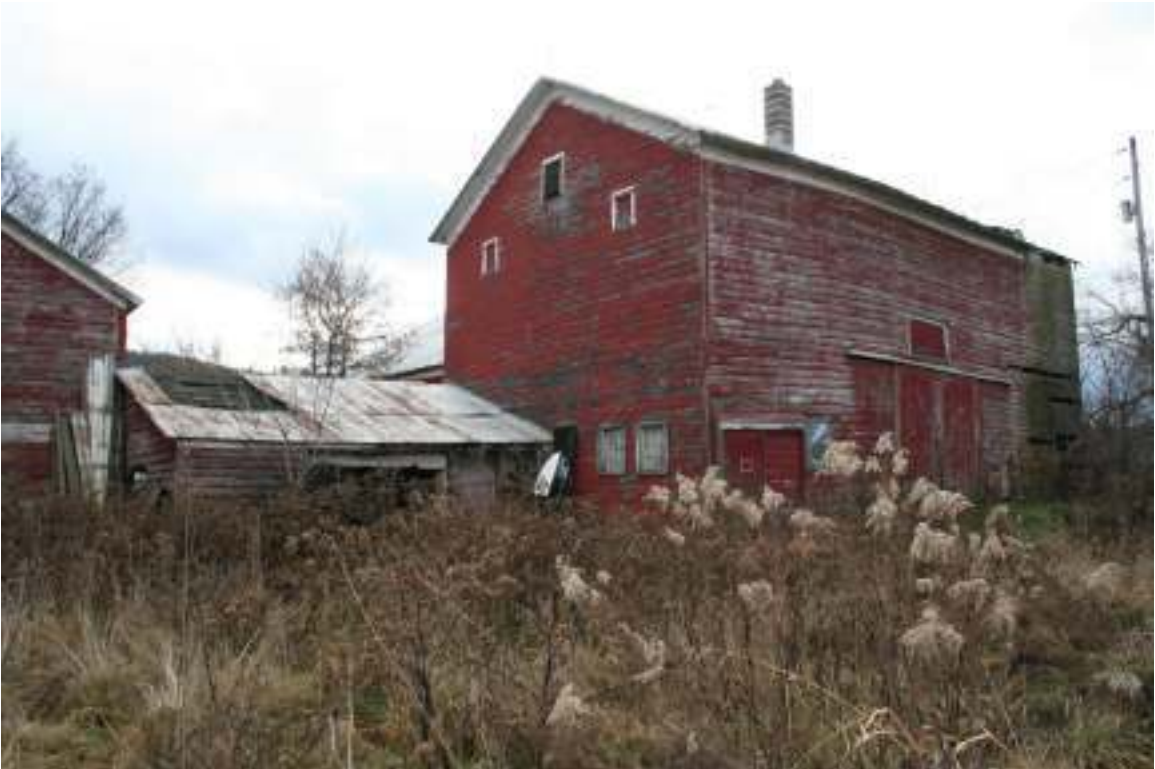
The rear, north facing façade of the Dutch barn opens into an English threshing barn addition, creating an overall T-shaped building (Page F35; Photos 6 and 7). A perpendicular English barn addition to the rear of a Dutch barn is a pattern uniquely found in the Schoharie Valley (Larson 1998; Zoch 2000). The English barn is rectangular in footprint and measures 53 x 20 ft, nearly doubling the footprint of the Dutch barn. An addition of this size would have intentionally been added to increase the volume capacity of the original barn. The English barn has a traditional interior arrangement with a central nave accessed by two wagon doors on the side-gabled, northern façade. A queen-post truss system supports the roof and rafters meet in an open joint. Two bays on either side of the central nave would have provided space for animal stalls or a haymow (Photo 16). Major timbers within the English barn are large, hand-hewn pieces. Studs, braces and rafters are vertical-sash sawn. Major joints are mortise-and-tenon and fastened with wooden pegs. The English barn addition appears to have been constructed using the square-rule method, not displaying any obvious marriage marks. Square-rule construction became wide-spread around 1820. In the 20<sup>th</sup> century, a concrete block chimney was added in the northeast part of the barn for an unknown purpose (Photo 17).

Photo 6. View of English threshing barn addition, facing southwest.

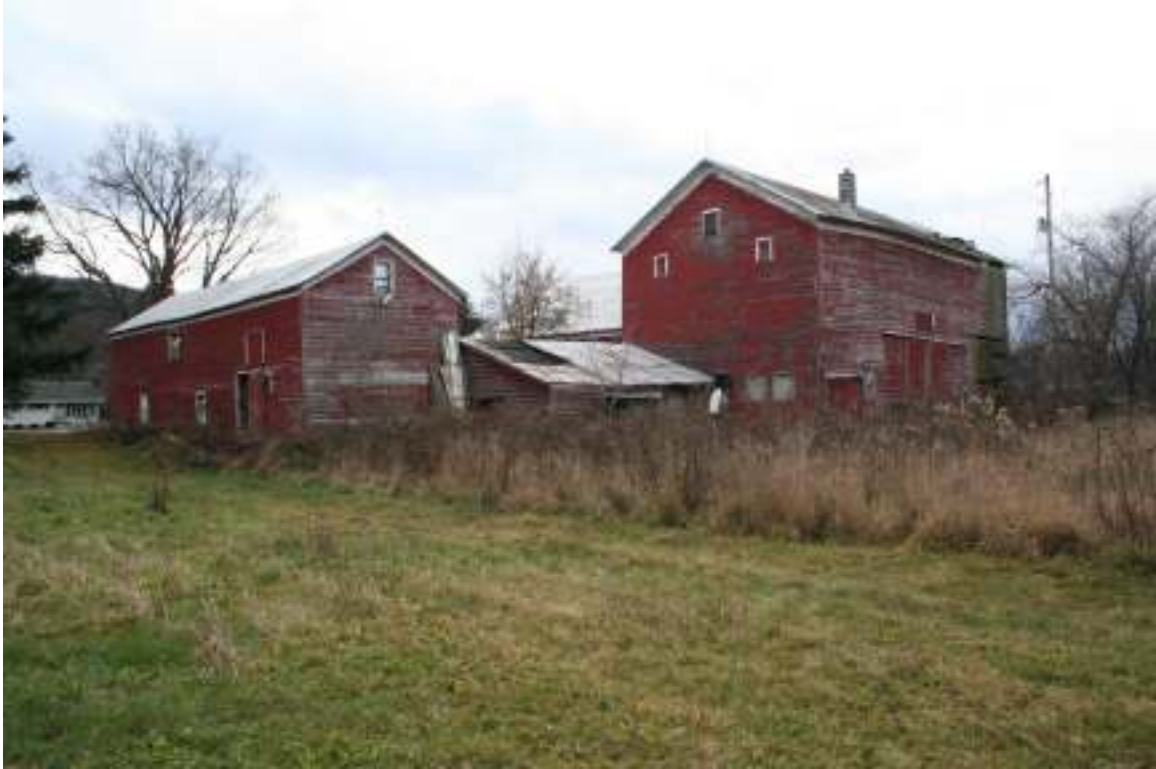
Together these four barns reflect an agricultural complex that served to meet the needs of a large dairy farm. As a stand alone structure, the appended Dutch barn represents an architectural expression of adaptation and innovation isolated to a small region. “T-bone” additions such as this are an anomaly to Dutch barn construction isolated to the Schoharie Valley region. While the Dutch barn is itself a rare survival in Schoharie County, its role through time in the expansion and evolution of the Shafer Farm lends itself to a wider realm of significance. The two smaller barn buildings are in good condition. The Dutch barn has some structural issues on its northern gabled end where the sill and end girt have been removed (Photo 23). The English barn addition suffers from isolated water damage due to a missing section of roof in its northwestern corner (Photo 16). The buildings are otherwise in fair condition (Photo 7, 8 and 52).

Photo 7. View of Shafer Farm Dutch Barn Complex, facing southwest.

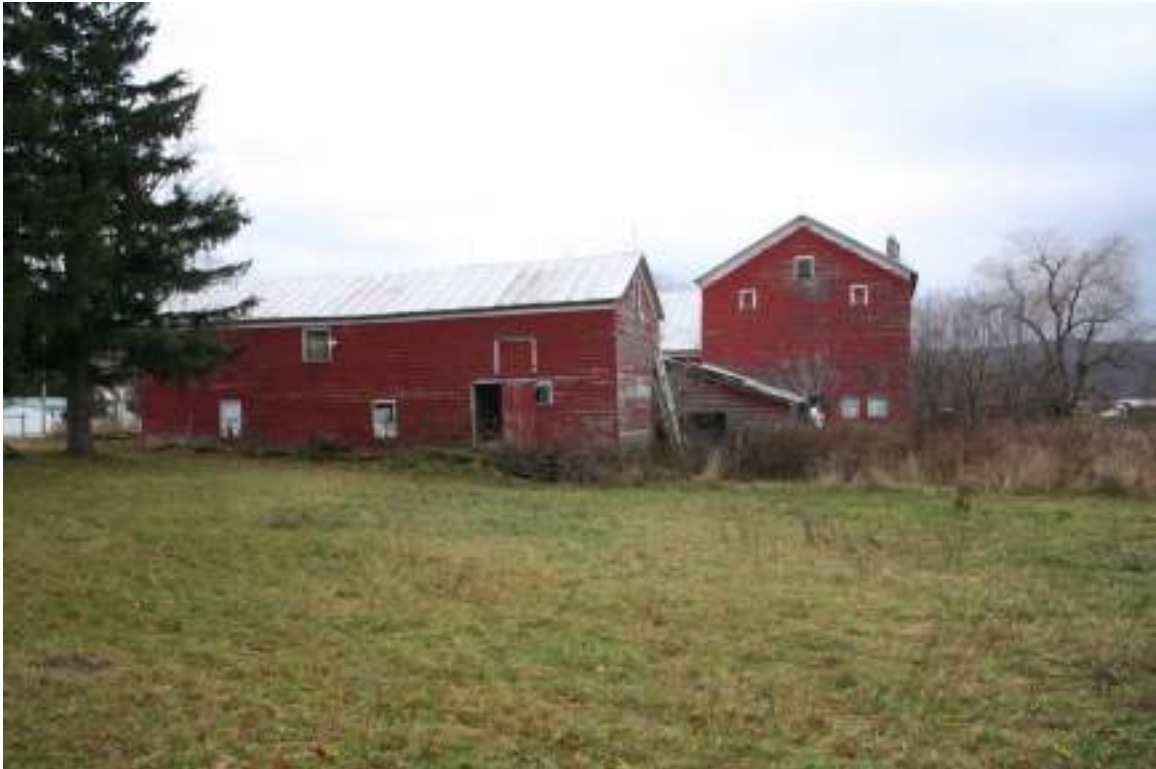
Photo 8. View of Shafer Farm Dutch Barn Complex, facing west.

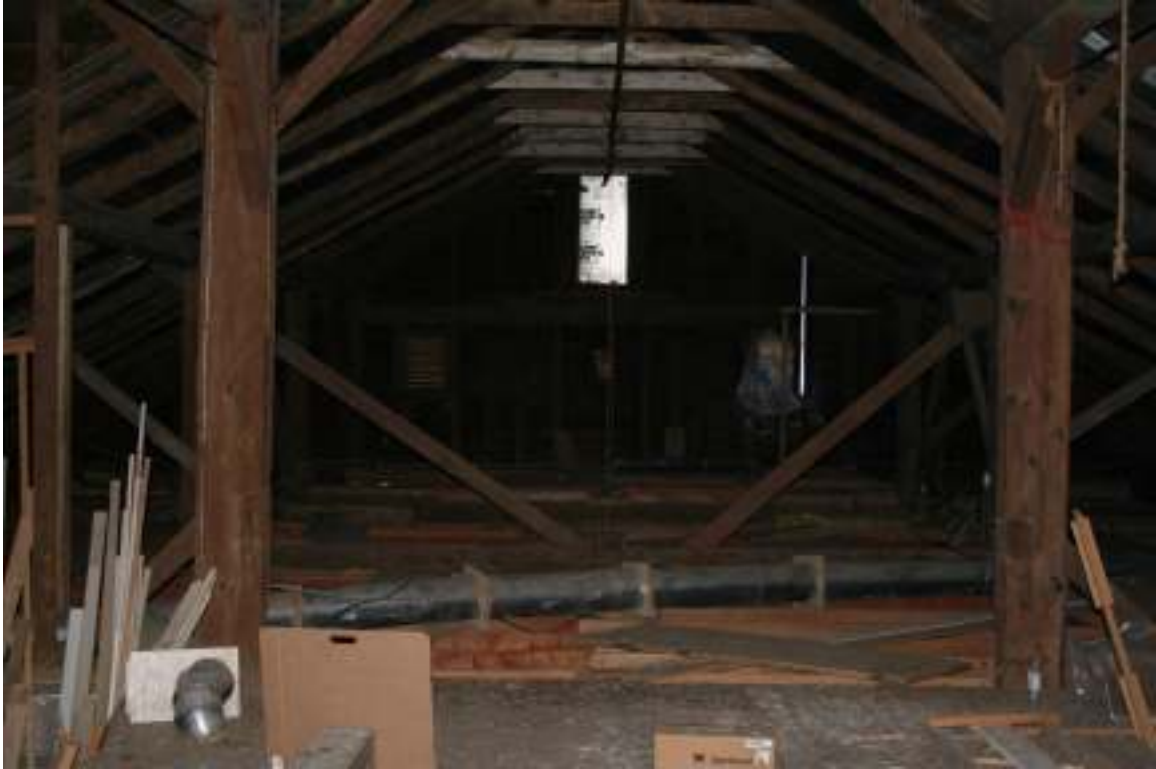
Interior framing in the Dutch barn consists of a four-bay H-bent truss system. The anchor beams are supported from beneath by upbraces extending from the H-bent column to the bottom of the anchor beam (Photos 9-11). The anchor beams span the central nave with a distance of 20 feet. A total of four H-bents (two end and two middle) within the barn are on roughly 13 foot centers. An upper transverse, tie beam extending parallel to the anchor beam originally joined into the top of only the third H-bent connecting the top of the columns at the level of a typical joist. This beam has been sawn off close to its joint on both posts (See page F36; Photo 11). Transverse side-aisle ties join into a longitudinal tie beam connecting the H-bents. One transverse side-aisle beam lines up with each H-bent, while two transverse beams intersect the longitudinal beam between H-bents (Photo 24). Rafters meet in an open mortise-and-tenon joint, fastened with a wooden peg. Rafters are notched over the top plate and continue uninterrupted to the roof plate. Pairs of longitudinal sway braces extend from the adjacent columns to the top plate between the bents (Photo 11). All original timbers within the barn's framing system are hand-hewn including posts, plates, girts, joists and rafters. Assembly of the barn followed the

Photo 9. View of the interior of Dutch barn from the loft area of the English threshing barn, facing south.

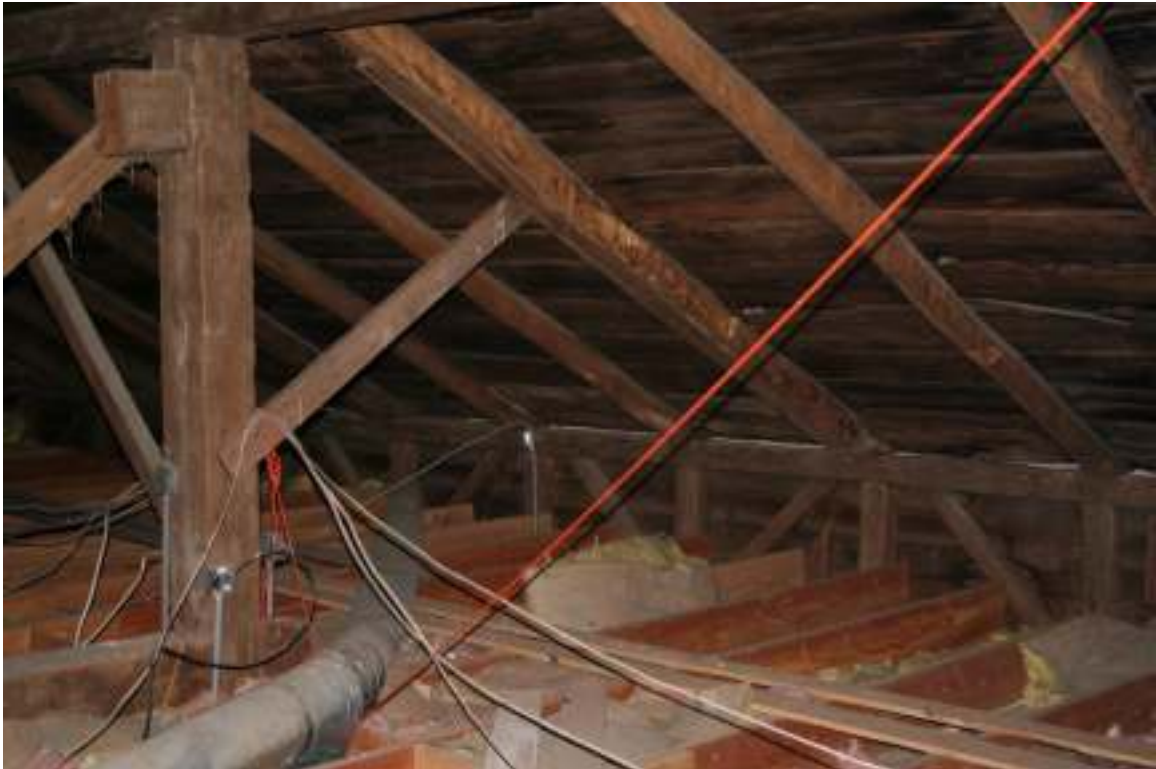
Photo 10. View of the interior of Dutch barn showing rafters, H-bent column, anchor beam, cut-off transverse tie-beam and modern drop ceiling, facing southwest.

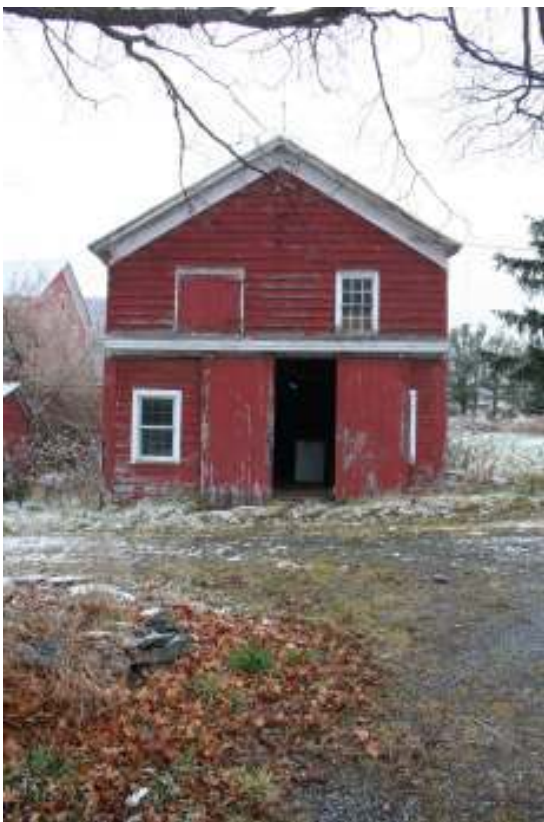
After the Dutch barn and its English barn addition had been built, a third barn was construction. This easternmost barn is also a gable front building being nearly two and a half times as long as it is wide (Photos 25 and 26). The exterior of the barn is clad in horizontal tongue-and-groove siding and was at one time painted red. Unlike other barns in the complex, a wide, white cornice board adds a note of stylization to the otherwise utilitarian design of the barn. This barn was likely the first building in the complex to be built with ornamental considerations and the Dutch/English barn was painted to mimic the cornice lines on this barn. Two vertical plank sliding doors allow entry on the front façade. Sliding doors such as these became increasingly popular in the late 19<sup>th</sup> century as farmers sought to reduce damage from winds when the doors were open (Noble and Cleek 1995: 54).

Photo 25. View of easternmost barn in complex, facing north.

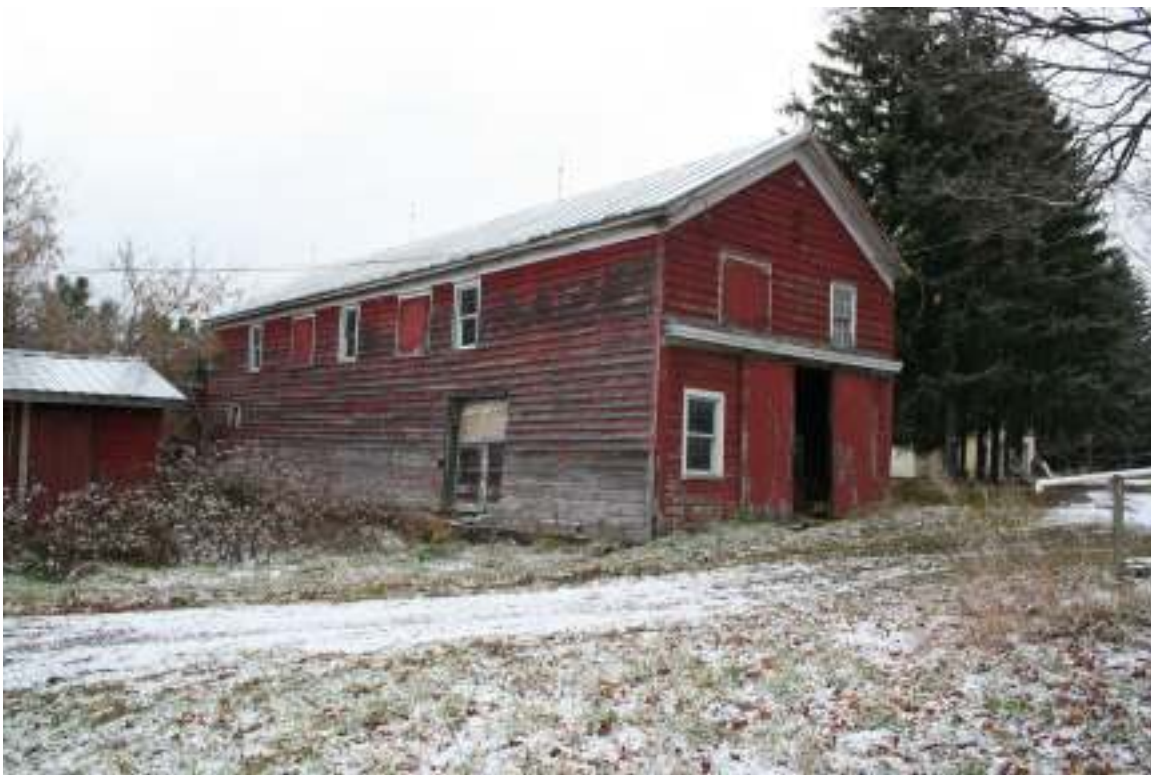
Photo 26. View of easternmost barn in complex, facing northeast.

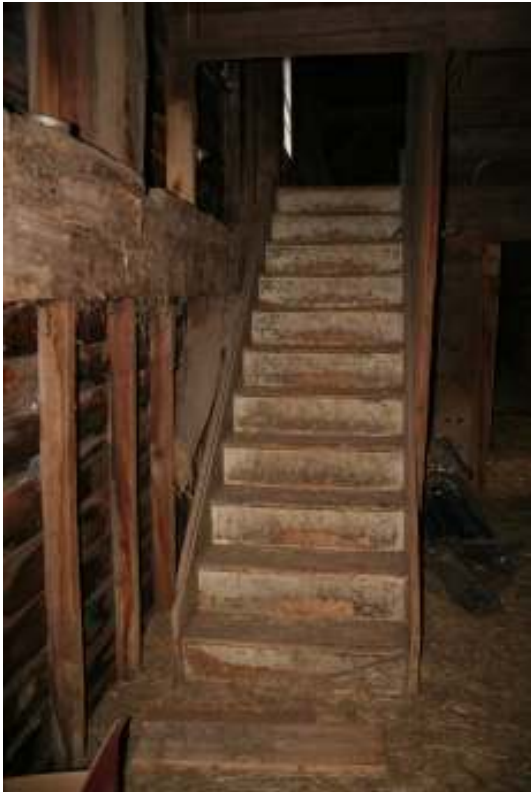
Timberframing within the easternmost barn is made of hand-hewn primary timbers (plate, joists, posts) and circular-sawn minor timbers (studs, rafters, braces) (Photos 35 and 36). Major joints are mortise-and-tenoned while joints with minor timbers are nailed with square-headed wire nails. Many of the major timbers appear to have been recycled from an earlier building as there are unrelated mortises throughout. The first floor has been partitioned into animal stalls with more recent lumber (Photos 28, 30 and 33). The floor throughout the southern first floor of the building consists of roughly squared planks measuring 2.5 x 6 inches sitting directly on the ground. Due to an uneven slope beneath the building, portions of the floor boards are supported by an uncoursed fieldstone foundation, particularly in the northern end of the building (Photo 27). The second story is unpartitioned and accessed via a reused house staircase (Photo 34). Portions of the

Photo 34. View of interior of easternmost barn showing resued staircase to loft, facing north.

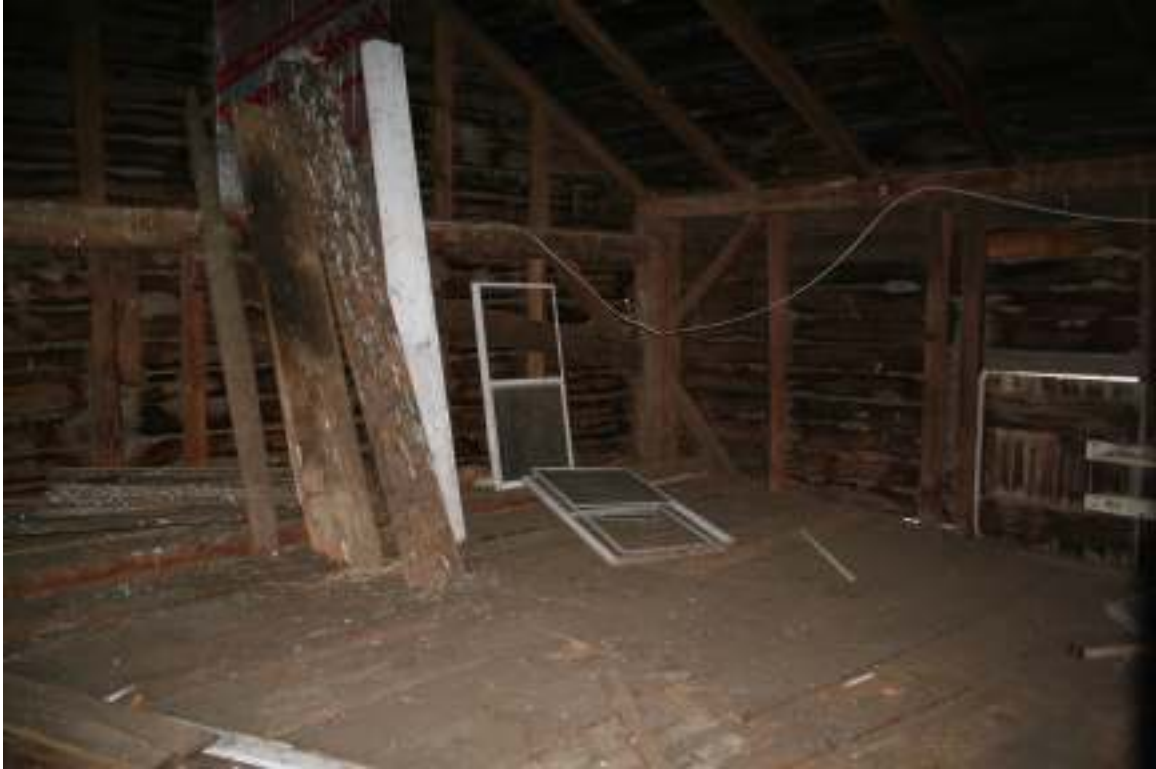
Photo 35. View of loft of easternmost barn, facing northeast.

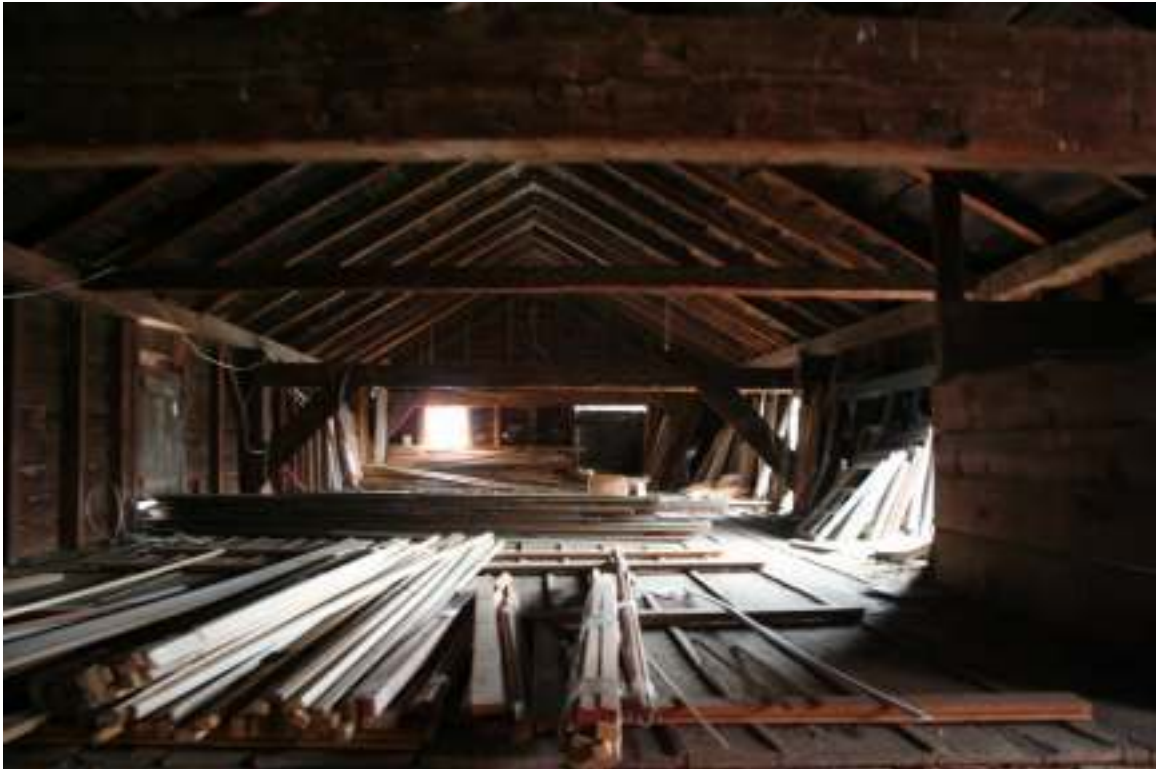
upper story are laid in board and batten plank flooring as to suggest grain or hay storage (Photo 36). Small exterior doors that access this upper story were likely used to put the grain or hay into place. Numerous 6/6 double hung sash windows that light both the first and second floors of the building were likely retrofitted into older door openings. Based on nail and timber evidence, the barn was likely constructed in the fourth quarter of the 19<sup>th</sup> century and was probably originally used dairying activities (based on white-washed walls in portions of the first floor) and grain storage (based on the battened loft). While the barn's structure has not been compromised and retains integrity, the barn has been most recently converted into horse stabling.

Photo 36. View of loft of easternmost barn showing battened floor boards, facing south.

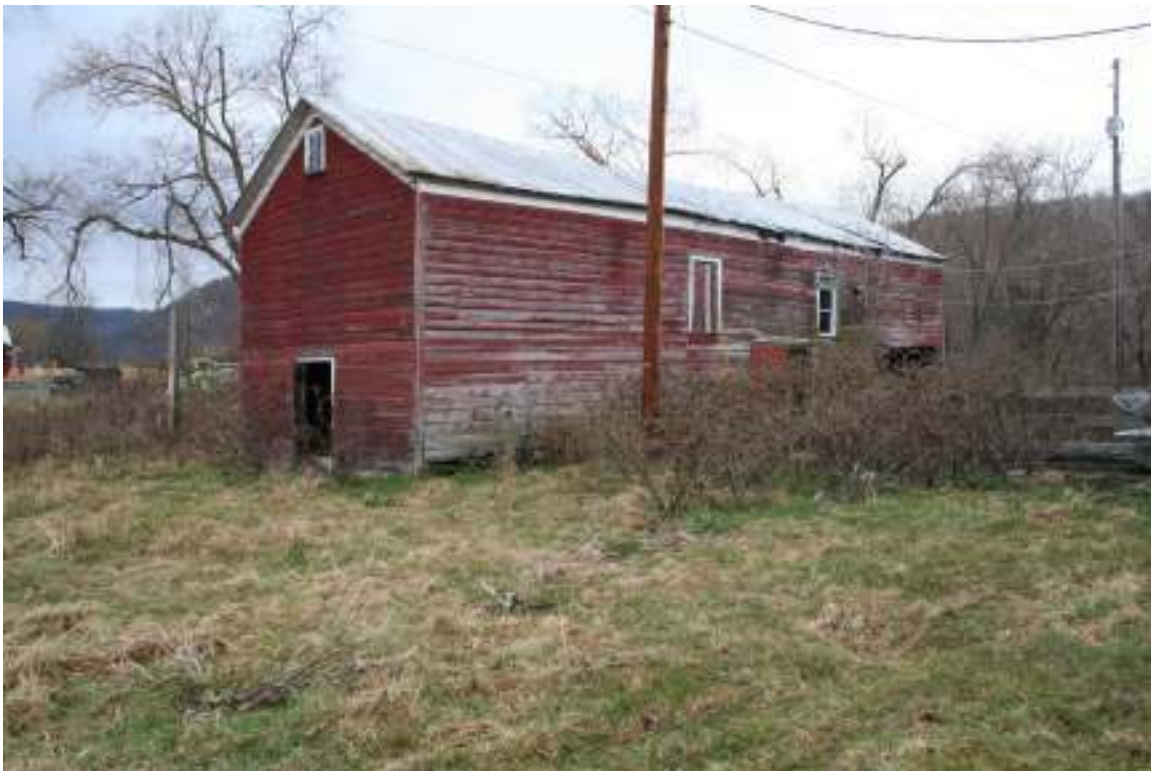
The westernmost barn exhibits a gable-front elevation completing the complex of gable-fronted barns. With a similarly sized front elevation as the stable, this barn is even longer being almost three times as long as it is wide (Photos 39-41). While major timbers within the barn are hand hewn (girts, plates, posts), minor timbers are circular sawn. In keeping with the other barns in the complex, the exterior is clad in tongue-and-groove siding and painted red with a faux white "cornice." A human-sized door provides the only access to the interior from the front façade. Other fenestration includes a sliding door and a larger door-less opening on the eastern elevation (Photo 42). Small hay loft doors occur throughout the upper story. Some of these doors have been converted to windows. The first story floor is poured concrete with a trough extending through the barn following the ridgeline. This area was used for feeding cattle (Photo 43). Mangers or hay troughs would have occurred along the long walls of this area, but no longer exist. A small stabling area has been created with more recent lumber in the middle section of the barn where the sliding door provides exterior access (Photo 46). The rear portion of the building is open on its eastern side and was used as vehicle storage (Photo 51).

Photo 39. View of westernmost, ground-level cow stable barn, facing northwest.

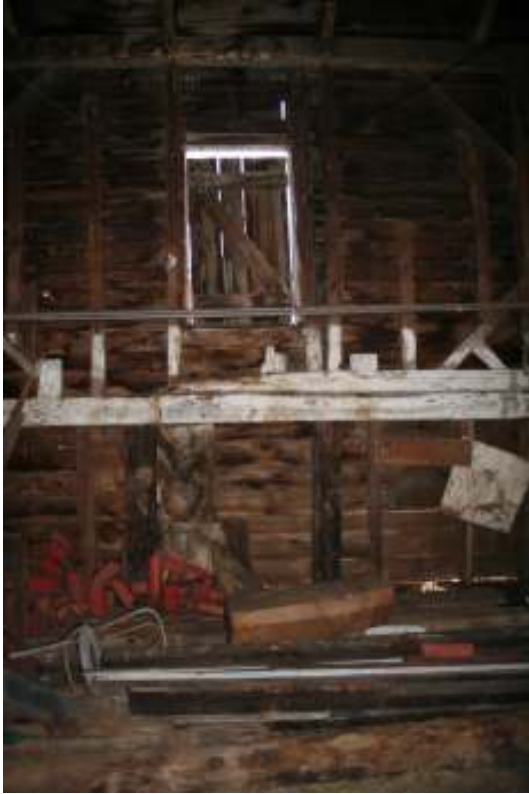
A second story hay loft remains in the rear portion of the barn and likely extended throughout, as was typical of ground-level cow stables (Photo 48). Small second-story openings would have been used to lift hay into the loft (Photo 45). Around 1920, barns of this purpose began to be erected with pole construction and with a gambrel roof so that the hay loft could hold a greater volume. In addition, gambrel roofs used a truss system for their roof construction that did not require a tie beam. Tie beams such as were

Photo 45. View of interior of cow stable showing location of original hay loft and small hay door, facing west.
